RE: Howard's Sand & Gravel; Minor; Individual Permit; SIC 1442; NPDES Compliance Evaluation Inspection; NPDES # NMU001191; August 7,2019

Compliance Evaluation Inspection Howard's Sand & Gravel Facility NPDES Permit No. NMU001191 August 7, 2019

NMED/SWQB Official Photograph Log

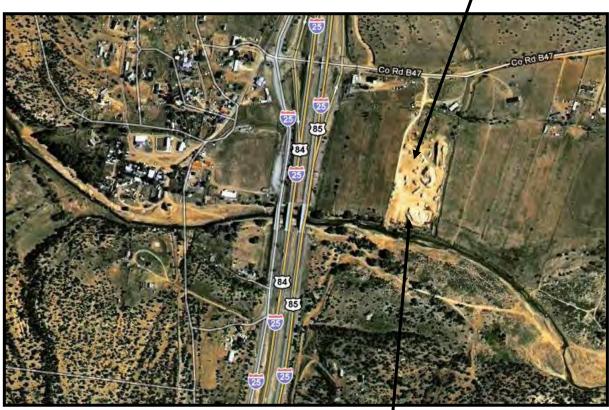
Screening/Washing Mechanism

Subject: South side of facility boarders Tecolote Creek where screening/washing mechanism operates.

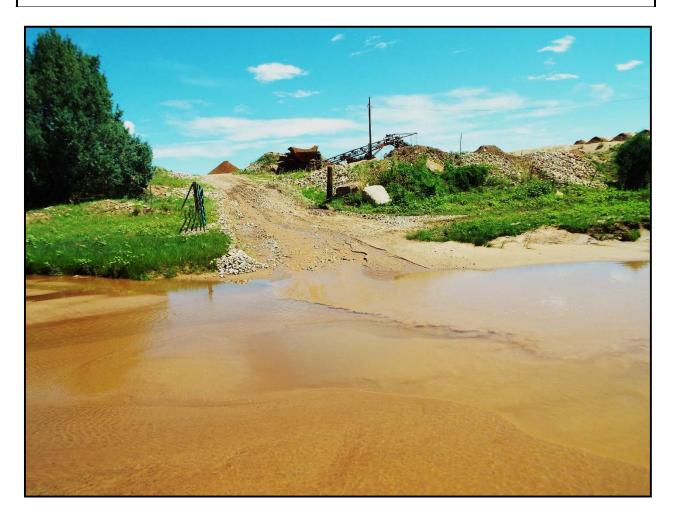
Photo #1

Subject: Unpermitted discharge of process water from separation/washing equipment into Tecolote creek.

The facility does not have NPDES permit coverage for the discharge of process water from the screening and washing area. The containment pond was filled up and was overflowing bypassing the berm. The facility needs to clean and maintain the settling pond from discharging process water or apply for a NPDES discharge permit. More information and how to apply for a NPDES permit can be found at https://www.epa.gov/npdes.

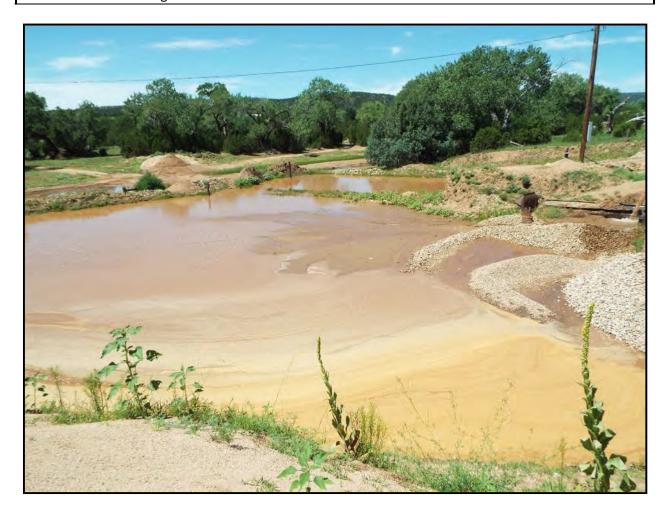
Photo # 2

Subject: The sediment ponds are next to Tecolote Creek. The ponds have not been cleaned and are overflowing into Tecolote Creek.

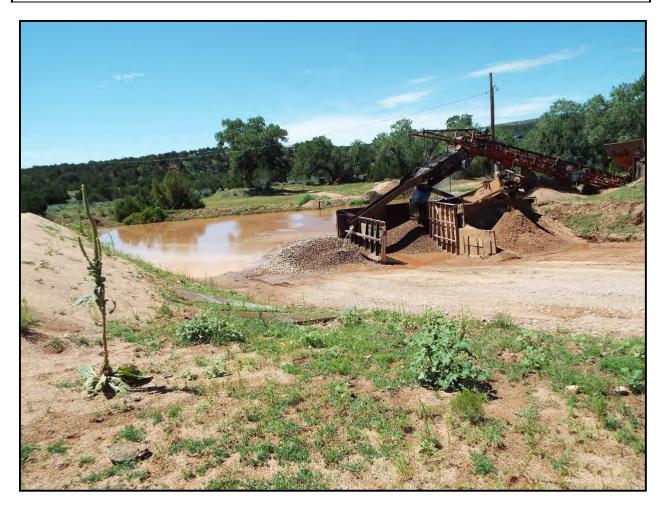
Photo #3

Subject Sand/Gravel washing area. Water is pumped from Tecolote Creek to clean the gravel and should be retained from reentering the creek.
